UNDERWATER BRIDGE INSPECTION REPORT

STRUCTURE NO. 6610

MINNESOTA RIVER

COLLINS ENGINEERS, INC.

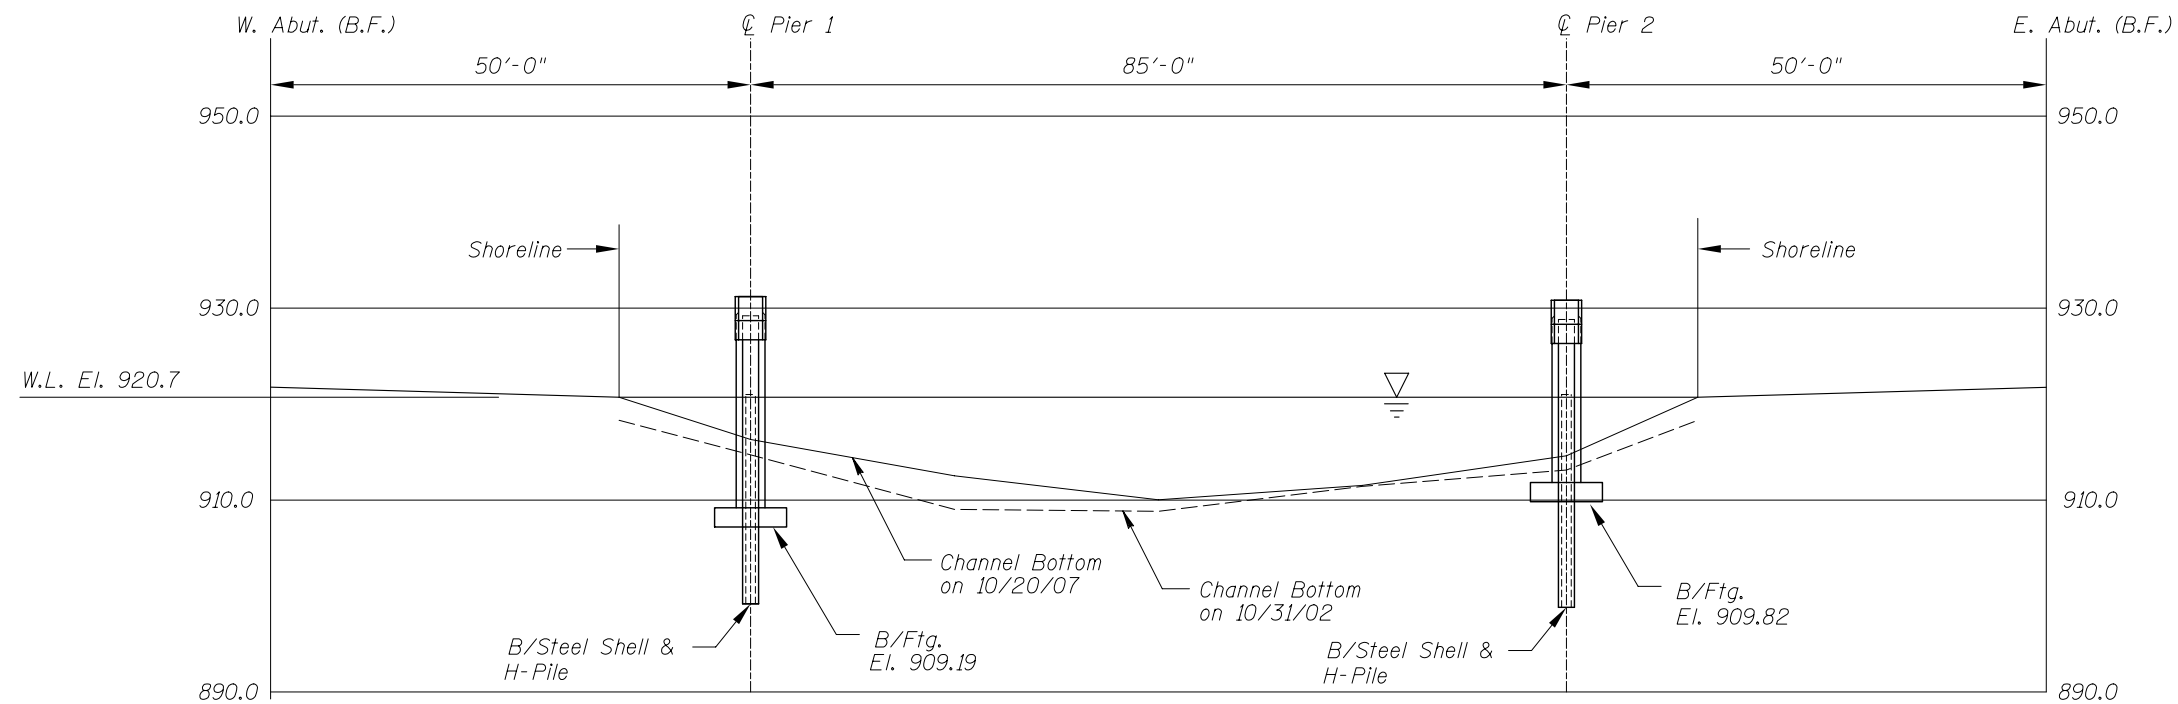
UPSTREAM FASCIA PROFILE

- The footing was exposed at the west side at the downstream column of Pier 2 with a maximum vertical exposure of 6 inches.
 - A light area of section loss was observed 2 feet above the waterline at the downstream nose of Pier 1, measuring 3 square inches with 1 inch of penetration.

- A light accumulation of timber debris, consisting of 6 to 8 inch diameter branches, was observed at the upstream nose of Pier 1 and extended along both sides of the pier.

- A light to moderate accumulation of timber debris, consisting of up to 1 foot diameter logs, was observed at the upstream nose of Pier 2 and extended to the shoreline, and a light accumulation of timber debris extended along both sides of the pier.

Monitor the accumulations of timber debris at the piers, and if found to be increasing, removal during routine maintenance to prevent further build-up and to restrict scour influence may be required.
